EXISTING FACILITY PRELIMINARY ASSESSMENT REPORT

Waterside at Flathead Lake Condominiums
7175 U.S. 93 South
Lakeside, Montana 59922

Report Date: October 16, 2023

Reported By: Studio Obermeier Sheykhnet Architecture
New Rome Engineering et. Al.

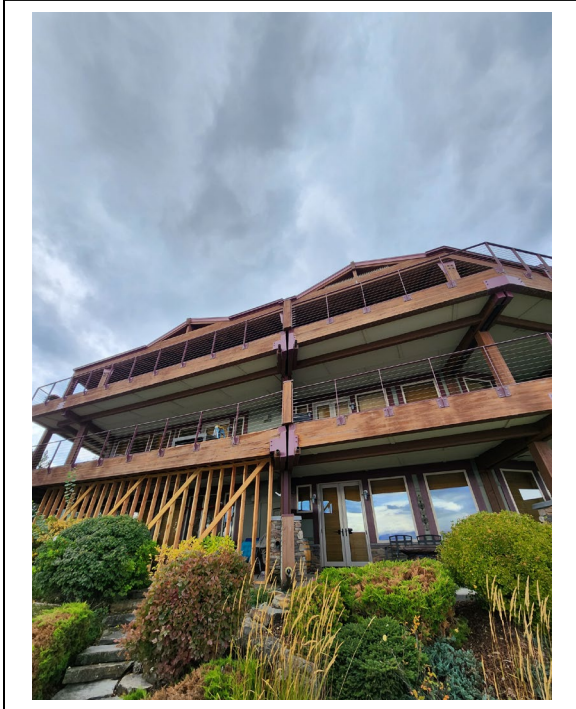
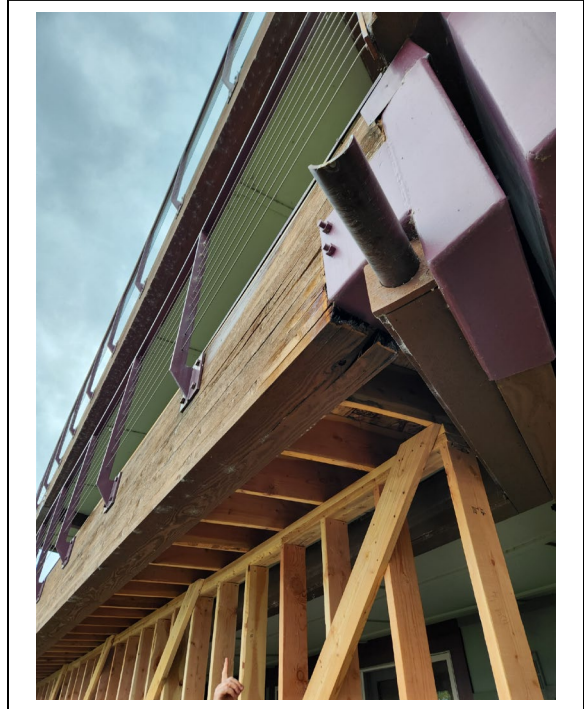
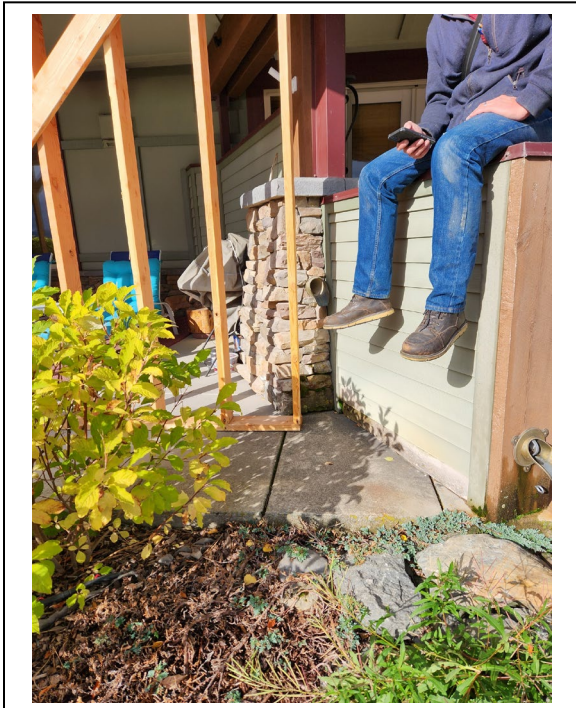
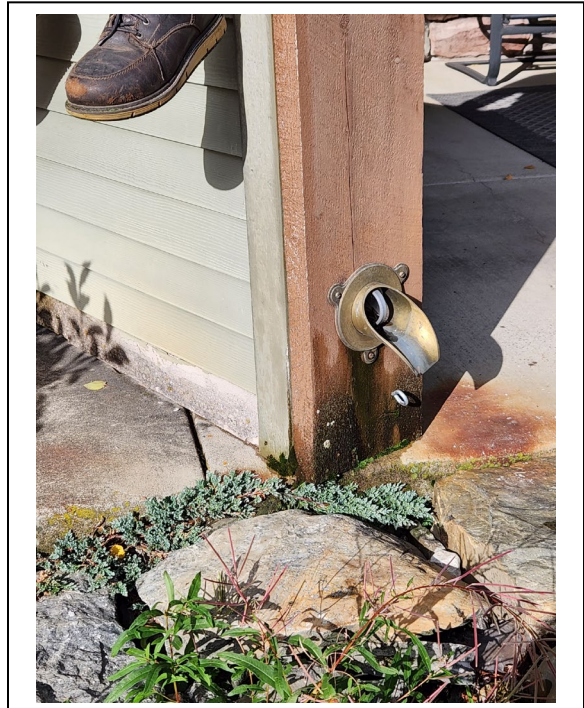
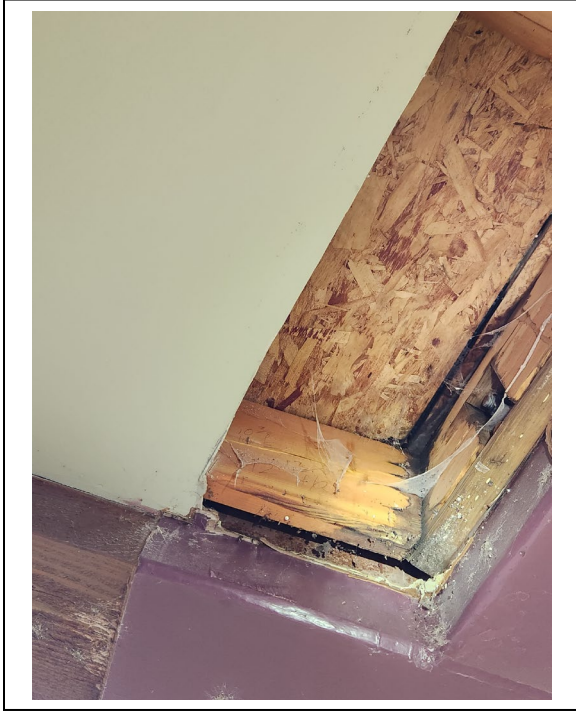
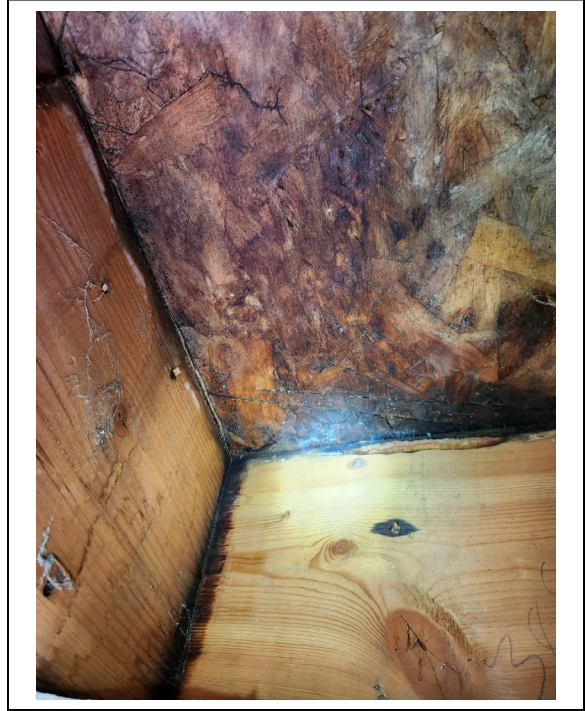
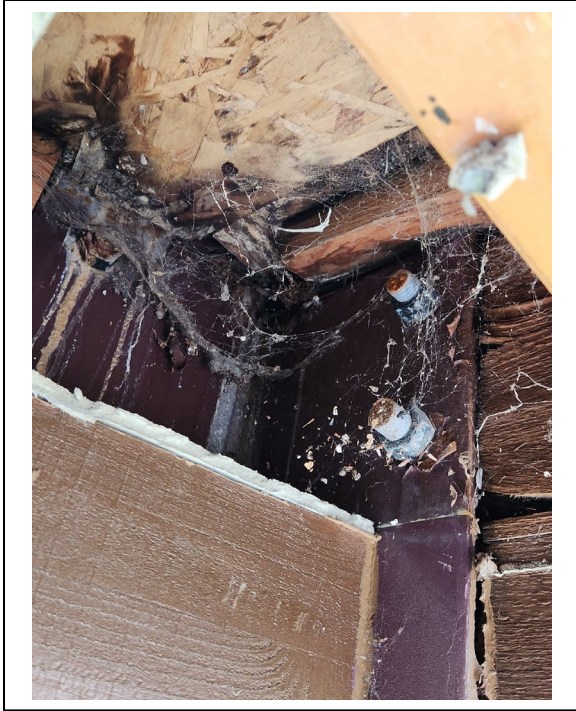
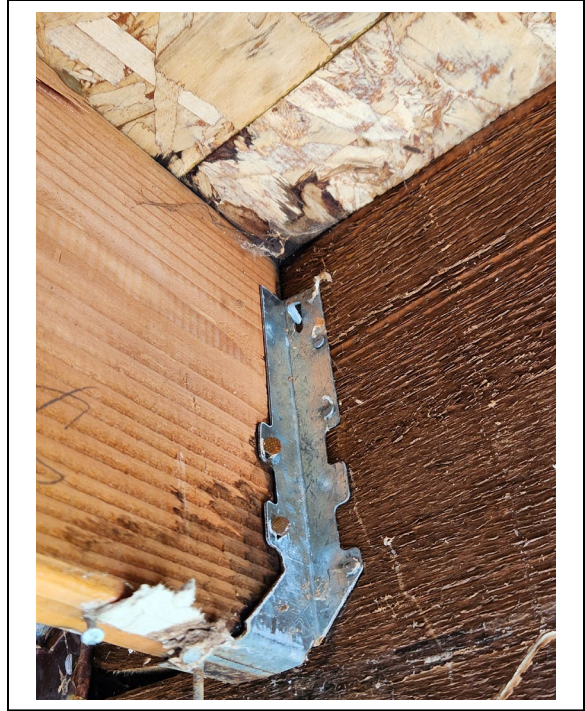
- a. Balcony soffit above Dwelling Unit # 105: (Figures 3-5 thru 3-12)
 - i. Open joist is exposed beyond column line.
 - ii. The second joist from the north is dry rotted- water intrusion is visible near the Balcony divider wall.

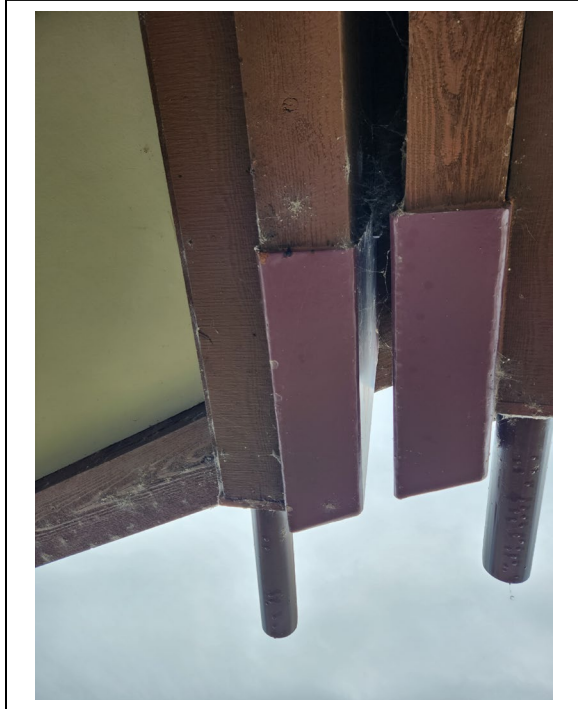
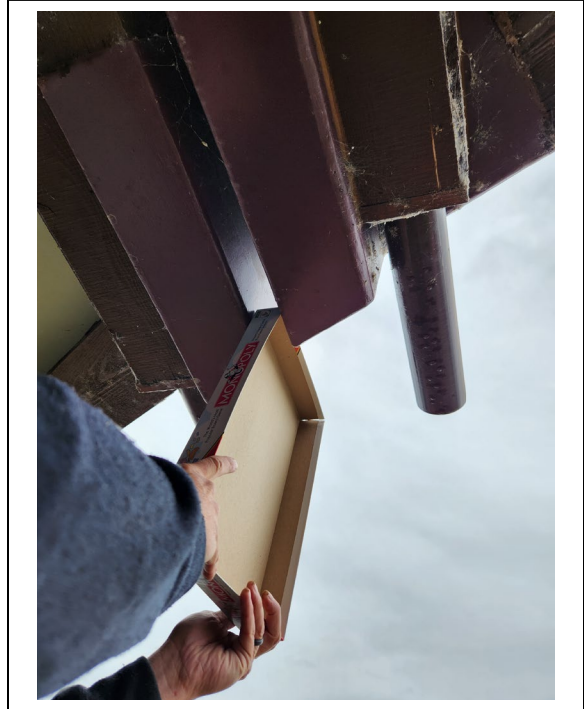
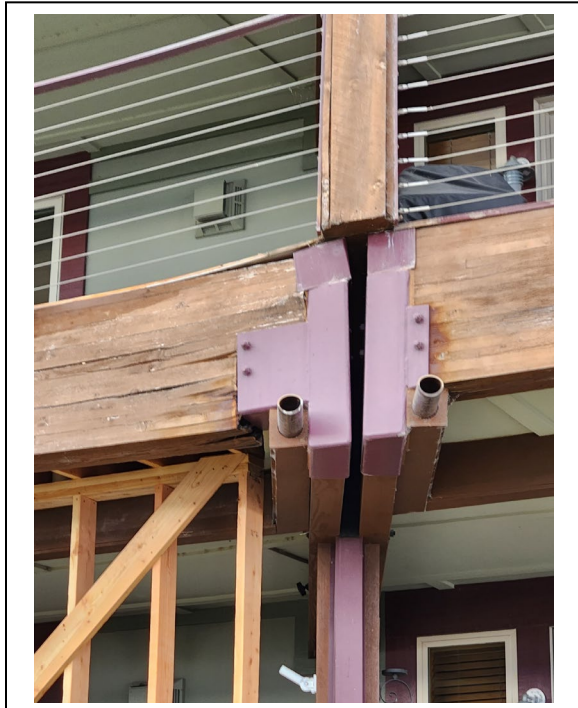
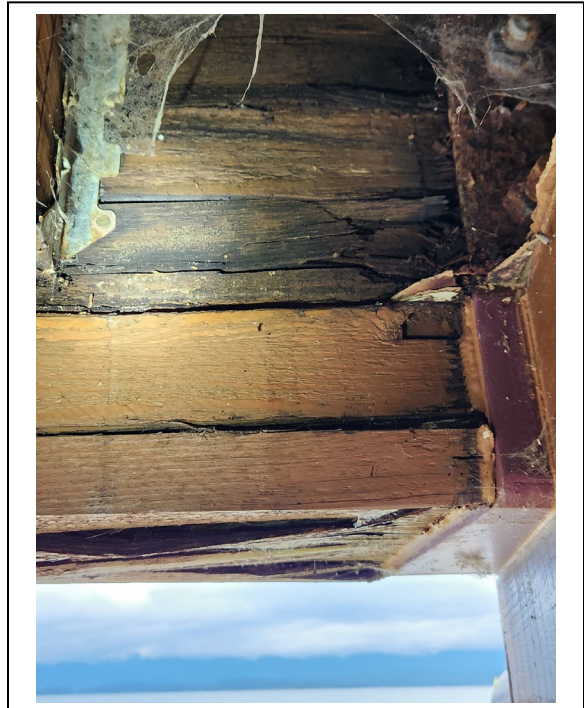
iii. Outrigger beam: (Figures 3-13 thru 3-24)

1. Twisting of the north side: gap is not parallel any longer, wedge assessed at 1.75"+-
2. End of beam covered with steel saddle fitting. Exposed end appears structurally sound.
3. No visible damage to the beam was observed.

iv. Perimeter beam: (Figures 3-13 thru 3-16)

1. Shearing off of the bottom laminations at the north end of near the bottom of the steel saddle plate fitting
2. Glulam is impregnated with waster, moist and soft to the touch.
3. Minor pressure pushes the probe through the softened wood. The beam is structurally compromised - immediate shoring required
4. Glulam beam delamination along adhesion lines appears in multiple locations
5. Storm water is running on the inside face of beam in two locations due to edge of deck detail failure.

- a. Perimeter beam
 - i. Replace existing glulam beam with new wood glulam beam in kind, same size and profile.
- b. Outrigger support beams
 - i. Trim end of rough sawn outrigger beam and connect new perimeter beam with a new metal saddle bracket.

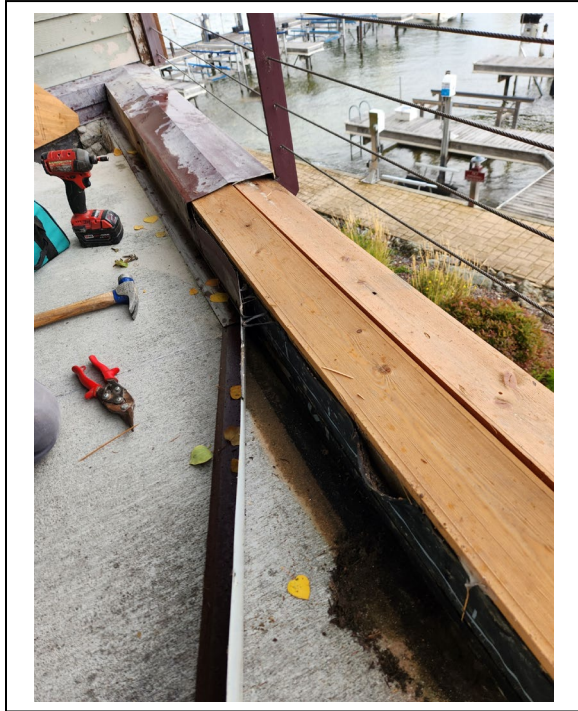
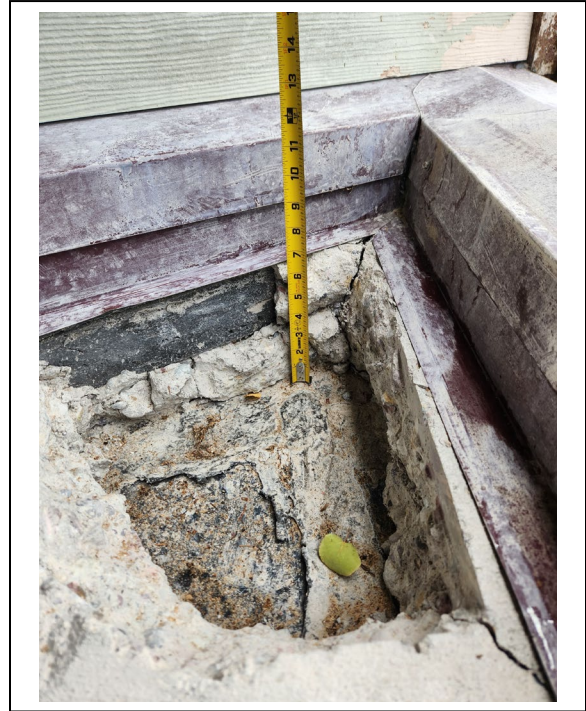
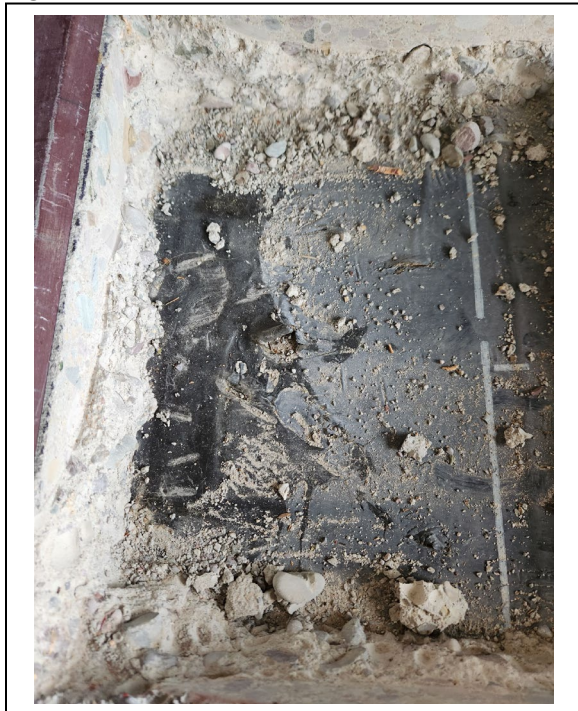
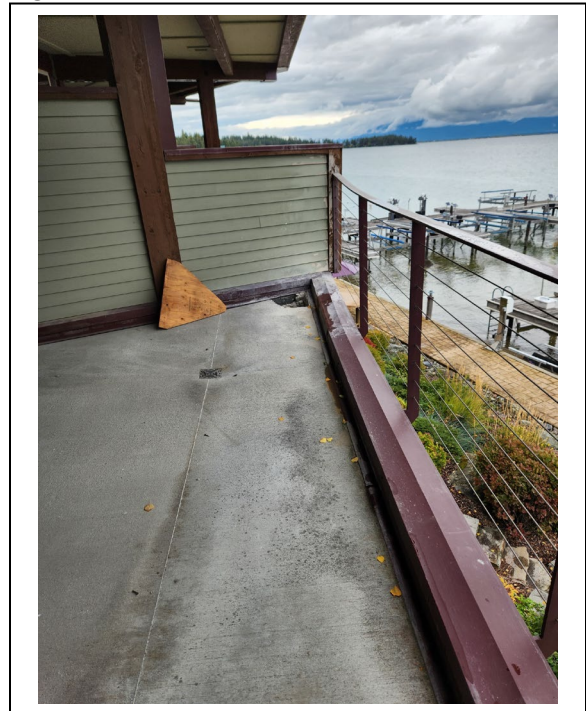
v. Balcony deck (Figures 3-17 thru 3-20)

1. No slope and negative drainage measured at the surface of concrete from edge of balcony to deck drains.
2. Waterproofing membrane adhered to interior face of beam. Beam sagged at mid-point of span. Transition from the horizontal to the vertical plane of the waterproofing membrane assumed to be compromised due to beam movement. Compressible material separating vertical edge of cast-in-place concrete from the waterproofing is holding water to the point of saturation.
3. Failure of edge flashing observed upon removal of flashing.
4. Near 2 water drip locations at the edge of balcony plywood is rotted to location of deck drain
5. Near 2 water drip locations at the edge of balcony the 2x10 wood joists are dry rotted and need replacement

- c. Balcony deck
 - i. Cut and remove 4-5 feet section of concrete deck along entire perimeter edge of the balcony.
 - ii. Replace damaged and/or rotted plywood deck.

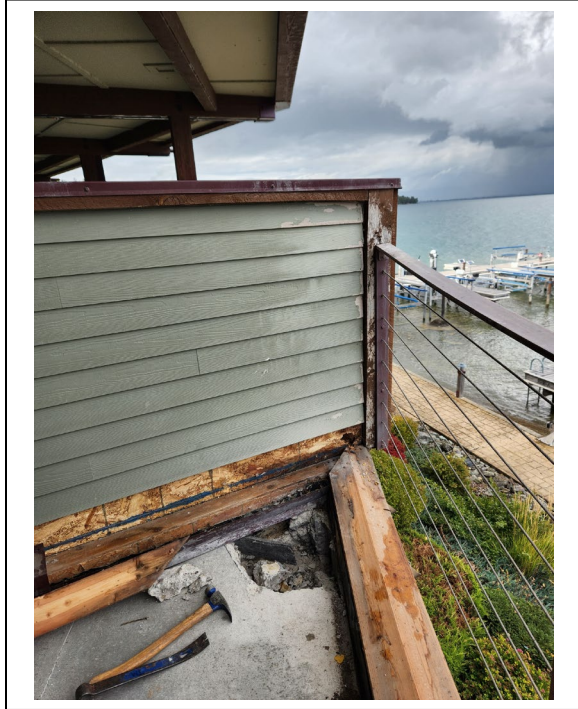
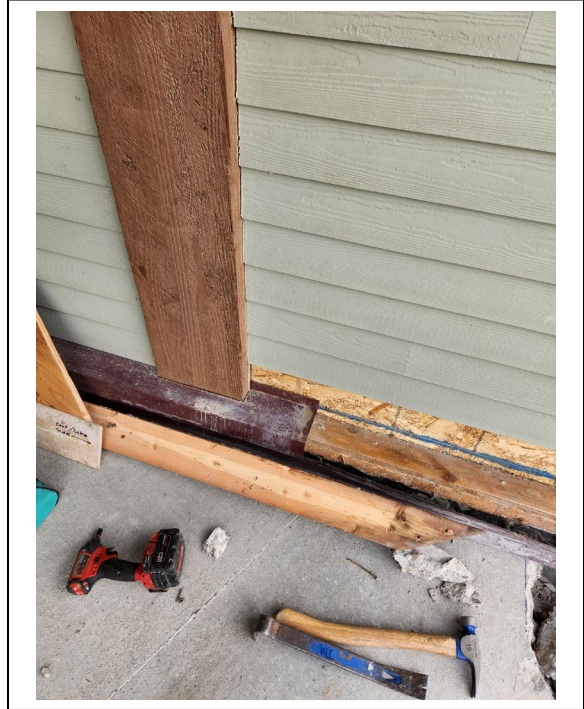
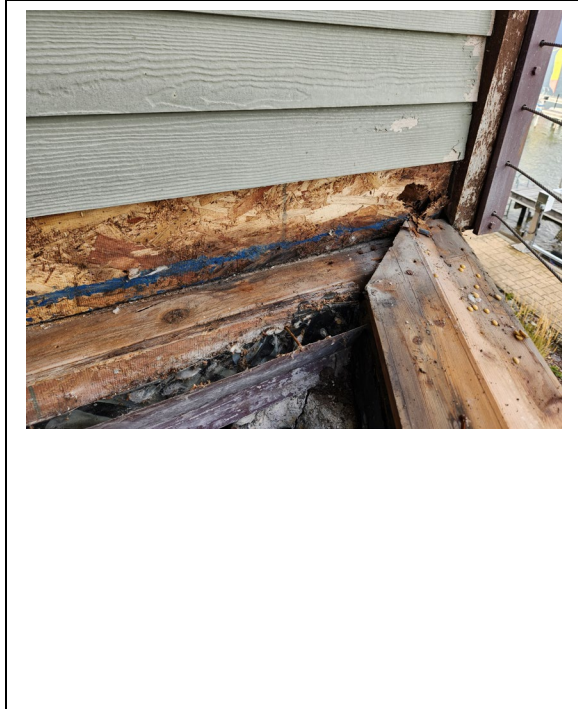
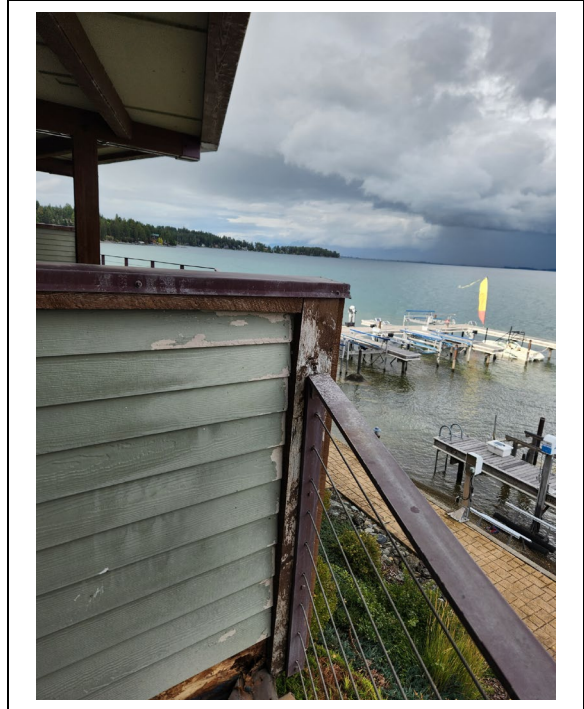
vi. Balcony divider wall on the north side: (Figures 3-21 thru 3-24)

1. Severe water infiltration at the vertical corner at outer south edge of the wall
2. Lateral deck drainage pipe extensions help with leading water away from dropping on top of demising wall, but driven rain and accumulating snow will continue to attach assembly
3. Missing through-wall base flashing
4. Rotted sub-straight discovered upon removal of siding

- d. Balcony railing
 - i. Existing railing to be removed, salvaged, and reattached to new perimeter beam.
- e. Balcony/Unit demising wall
 - i. Replace any damaged and/or rotted wood finish panels with new panels in kind; prime and paint to match existing.

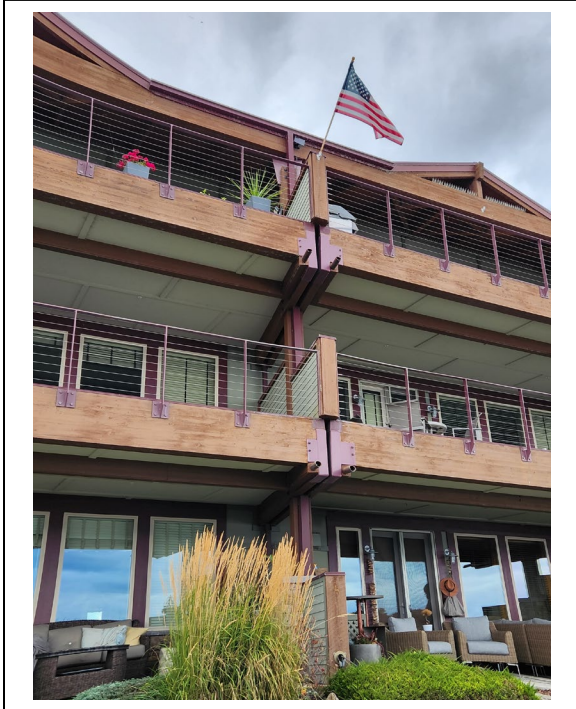
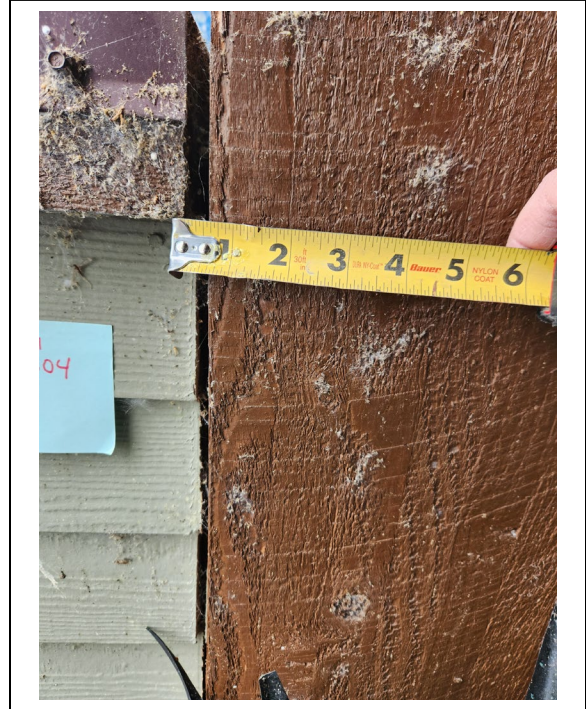
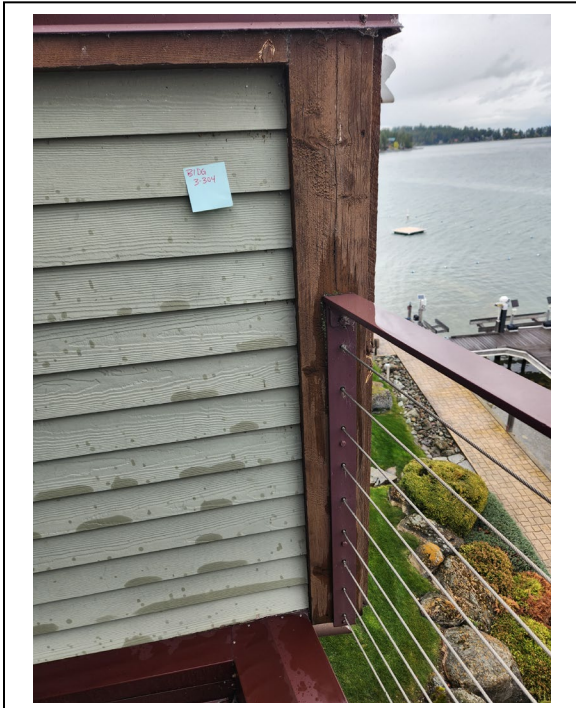
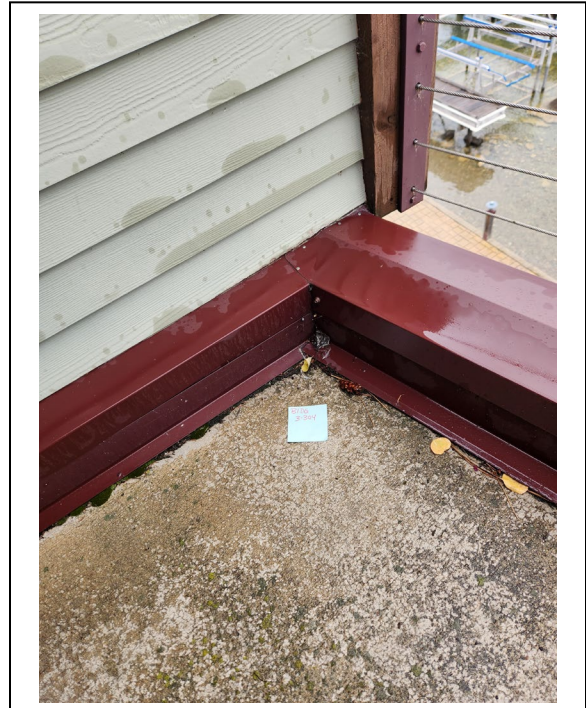
c. Balcony of the Dwelling Unit # 204: (Figures 3-25 thru 3-28)

1. Twisting of the south side: gap is not parallel any longer, wedge assessed at 1.75"+-
2. End of beam covered with steel saddle fitting. Exposed end appears structurally sound.
3. No visible damage to the beam was observed.

- viii. Perimeter beam:
 - 1. Minor discoloration and delamination consistent with the age of building
 - ix. Balcony deck
 - 1. Positive slope measured both sides of deck drains.

- 2. Minor deterioration consistent with the age of building.
 - x. Balcony divider wall on the north side
 - 1. Observed water infiltration at the vertical corner at outer south edge of the wall

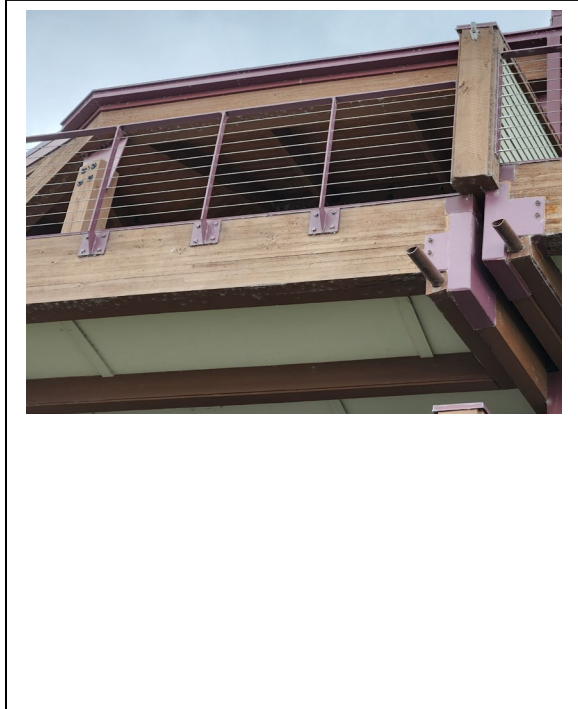
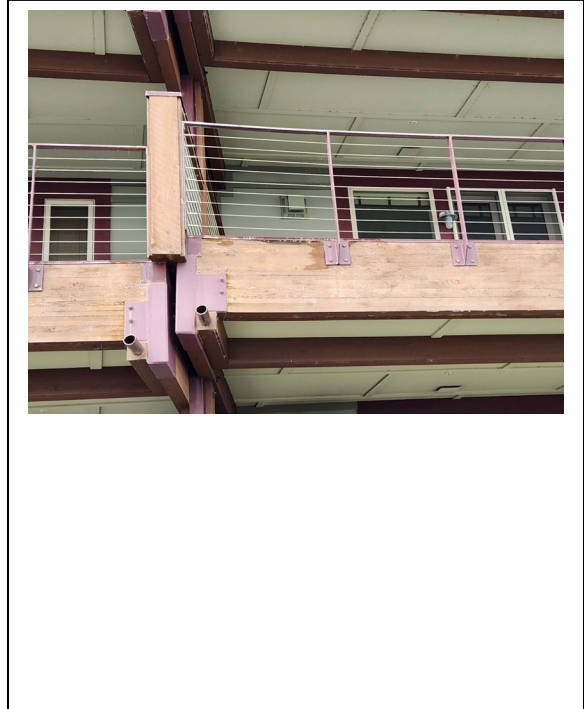
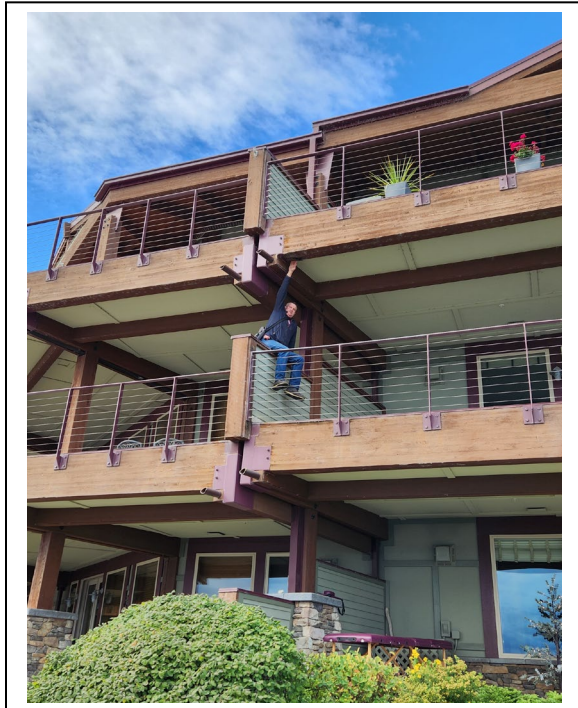
- 2. Discoloration and minor deterioration of the siding material.
- d. Balcony of the Dwelling Unit # 203: (Figures 3-29 thru 3-31)
- xi. Outrigger beam: *(Exhibit A)*

- 1. Twisting of the south side: gap is not parallel any longer, wedge assessed at 1/2"+-
 - 2. End of beam covered with steel saddle fitting. Exposed end appears structurally sound.

- xii. Perimeter beam: *(Exhibit A)*
 - 1. Removed two soffit material panels both sides of the beam.
 - 2. Perimeter beam shows significant deterioration on the south side

- 3. Temporary shoring is needed at perimeter beam south end above and below.
 - xiii. Balcony deck *(Exhibit A)*
 - 1. Condition similar to Dwelling Unit # 205

- xiv. Balcony divider walls: *(Exhibit A)*
 - 1. Observed water infiltration at the vertical corner at outer edge of the wall
 - 2. Discoloration and minor deterioration of the siding material at top and bottom of the wall.

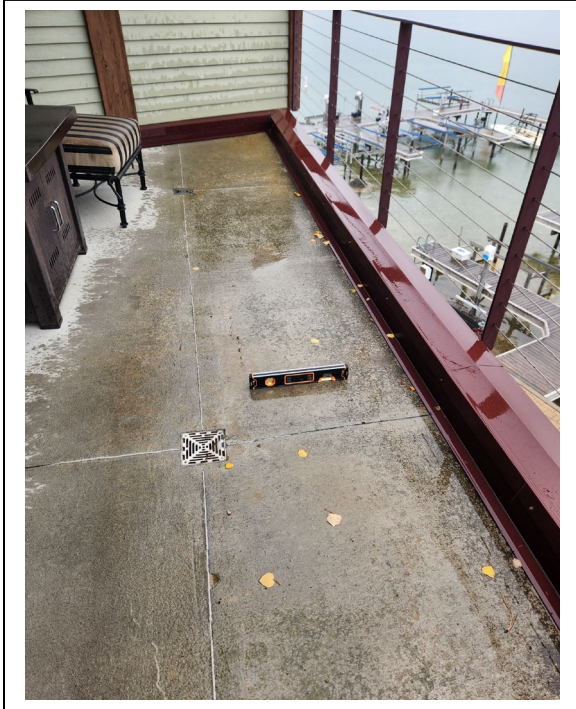
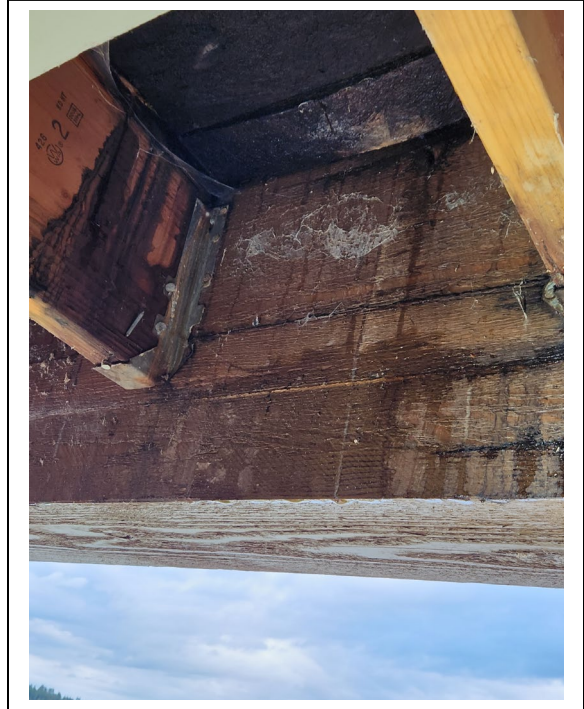
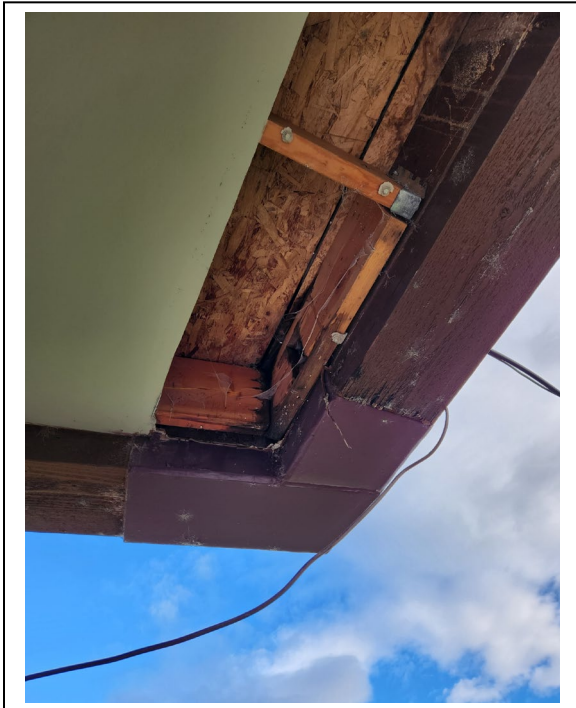
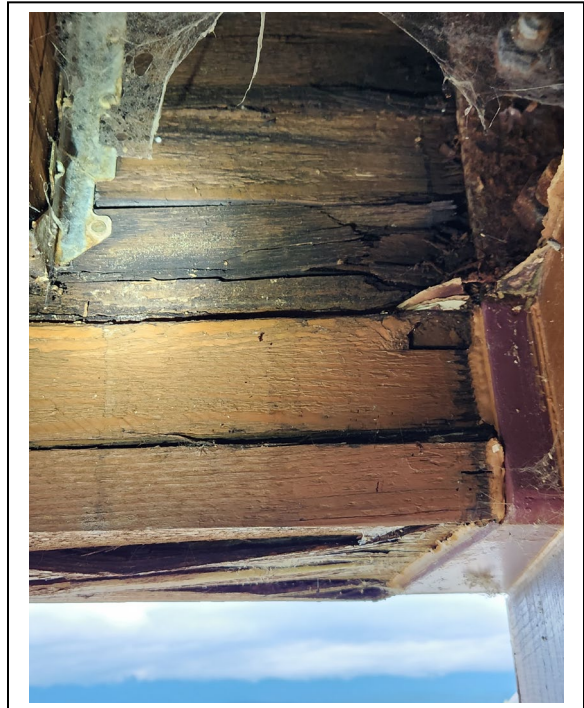
- e. Balcony of the Dwelling Unit # 201: (Figures 3-32 thru 3-35)
- xv. Soffit material removed below the beam on both sides.
 - xvi. Shearing off the end at the glulam balcony perimeter beam by bottom plate of steel saddle fitting observed at south end.

- xvii. Soft and soggy beam's end on the north side.
 - xviii. Beam is compromised and requires temporary support on both ends.
 - xix. South soffit removed. The following observed in the cavity:

- 1. The glulam balcony perimeter beam is soft, soggy with significant loss of structural integrity.
 - 2. The southmost 2x10 wood joist is dry rotted.

- 3. OSB sheathing is blackened and compromised.
 - xx. Dripping of rainwater is observed in two spots off the back of the glulam balcony perimeter beam.

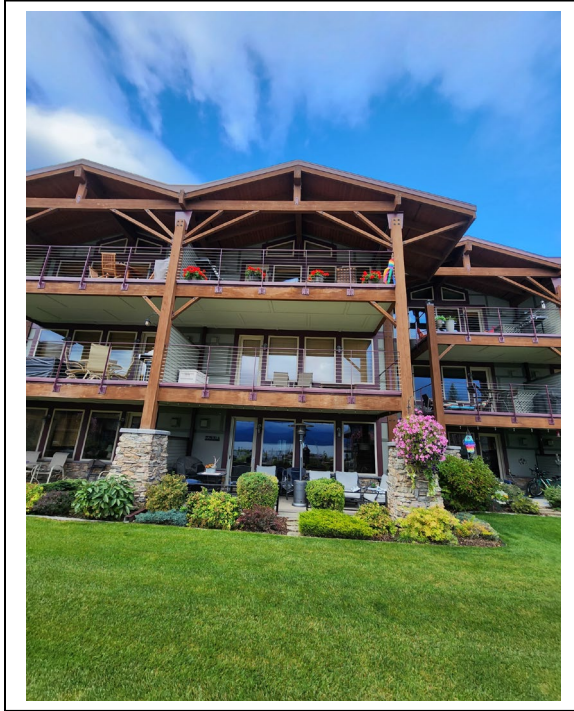
- a. **Building #1:** (Figure 1-1)
 - i. Water absorption by balcony beams due to recent rain was observed at all levels of balcony beams. (Figure 1-2)
 - ii. Balcony beams at dwelling units #204 and #304 are impregnated with water made visible to recent rain. Discoloration & delamination is clearly visible. (Figures 1-3, 1-4)

Figure 1-2: Units 104, 204 and 304

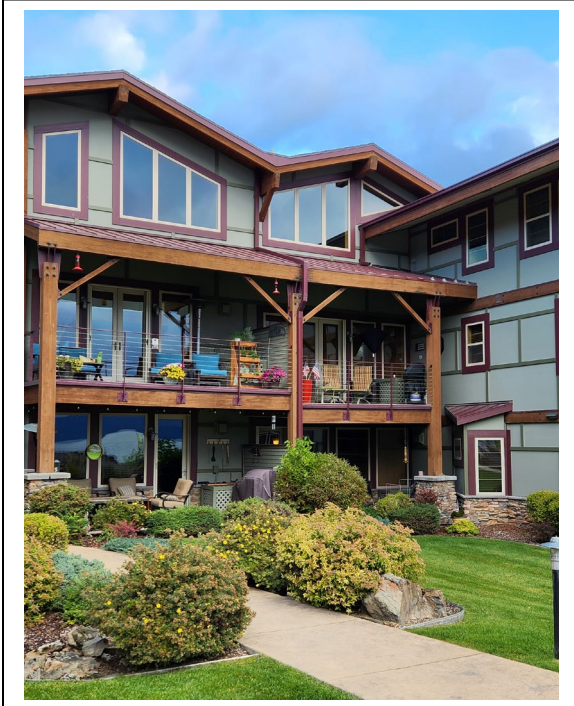
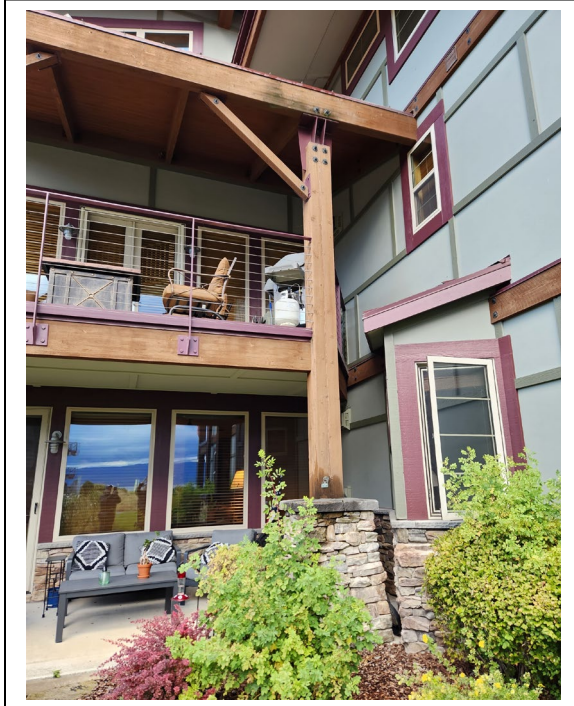
- i. Units #201 and #202 balcony roof beams are impregnated with water due to recent rain. Discoloration and staining from prolonged exposure and absorption of water is clearly visible. (Figure 2-3, 2-4)
- ii. Unit 101 and 102 balcony columns show visible signs of absorbing water at bottom stone base, as well as at upper unit balcony roof. (Figure 2-5 thru 2-8)
- iii. Primary roof run-off has been routed just above Unit #202 affected area by a downspout, but terminates on the balcony roof, resulting in added runoff at balcony roof edge. (Figure 2-3)
- iv. Catching runoff required from the water collection area (roof) to discharge point on the ground (splash block at ends of downspouts).
