To:	David Roberts & Waterside HOA	Date of Issuance:	1/25/2024
Company:	Western Mountains Property Management	Project:	Waterside Condos Bldg. 3
From:	OS Architecture	Project No.:	54015
Subject:	Review of Structural Systems Letter	File Name:	WS3 OSA Memo – Structural Members
Attachments:	None	Via:	EMAIL

WATERSIDE CONDOS – STRUCTURAL BEAM SYSTEMS

Re: **Opinion of Purpose of Exterior Deck Beam Member**
7175 South U.S. 93
Lakeside, Montana 59922

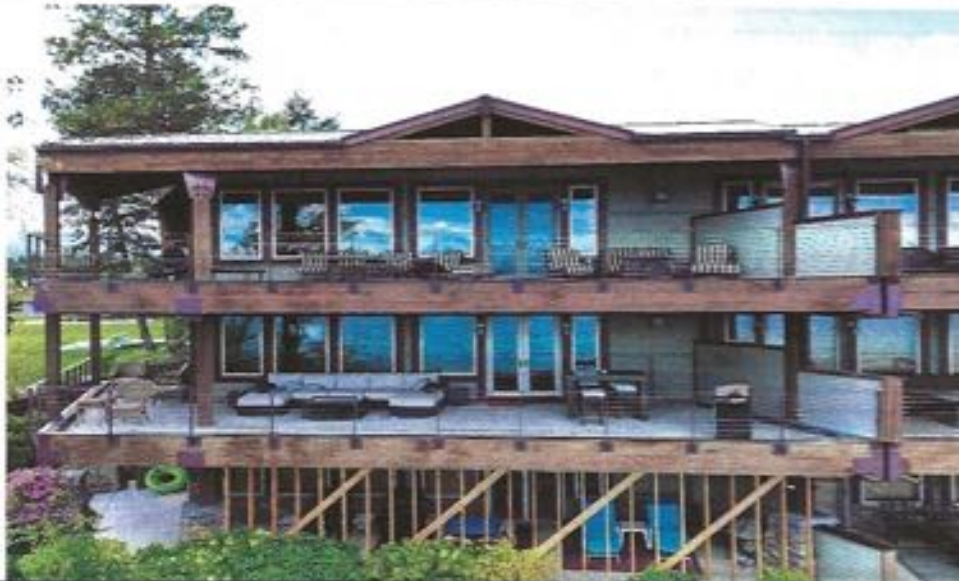
Some of the Parallel beams have evidence of deterioration as previously noted by Obermeier-Sheykhet (OS) in previous memorandums.

Photograph: East-Facing Decks of Units 105, 205 & 305

1. **Parallel Beams:** These are the glue-laminated beams that are closest to the camera in the Photograph. These Beams support the exterior ends of the 2x joists and floor sheathing for these exterior decks.
2. **Perpendicular Beams:** These are the wood-sawn beams that are placed beneath the deck partitions and beneath the exposed wood columns as seen above. These Beams support the Parallel Beams at each end of these Parallel Beams, via metal connections as seen above. These Beams are supported near the east ends by Exposed Wood Columns and at the west ends by Concealed Wood Posts at the Perimeter Wall Studs.
3. **Metal Connectors:** These are specialty-made steel supports located at each end of the Parallel Beams and are also connected to the east ends of the Perpendicular Beams, thus allowing the support of the ends of the Parallel Beams.
