EXISTING FACILITY PRELIMINARY ASSESSMENT REPORT

Waterside at Flathead Lake Condominiums
7175 U.S. 93 South
Lakeside, Montana 59922

Report Date: October 16, 2023

Reported By: Studio Obermeier Sheykhnet Architecture
New Rome Engineering et. Al.

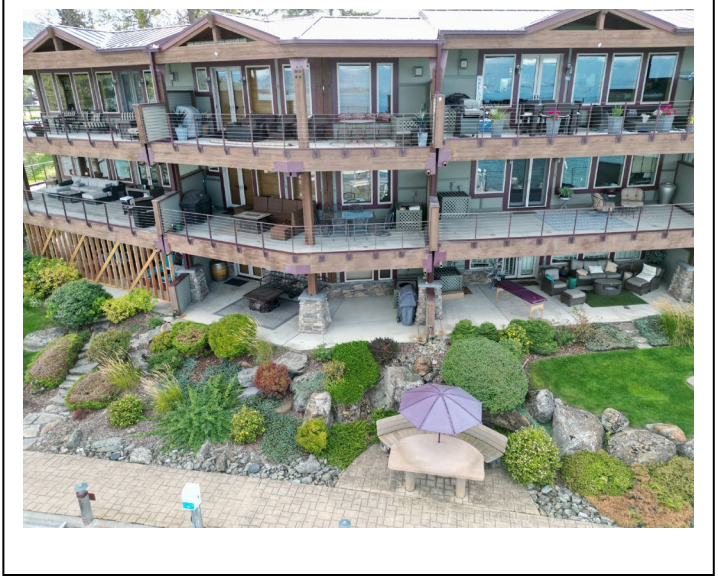
Figure 3-2: Units 104, 204, 304 & 103, 203, 303

For the remainder of Building 3, additional evidence of glulam beam deterioration was observed at the balconies of Units 201, 203 and 303. As a result, the OSA team issued a Proposal Request to the Property Manager's contractor to provide additional steel support columns at these specific locations for temporary bracing. Refer to attached Proposal Request #1 exhibit.

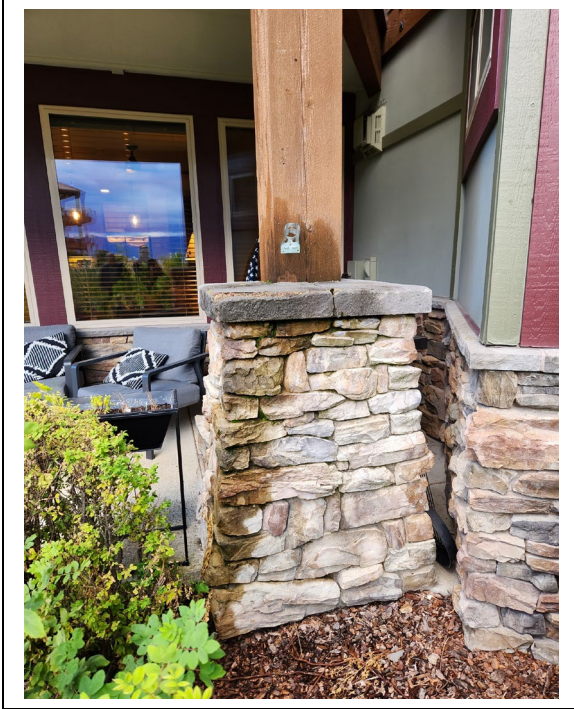
Figure 2-5: Unit 102 Column

- i. Units #201 and #202 balcony roof beams are impregnated with water due to recent rain. Discoloration and staining from prolonged exposure and absorption of water is clearly visible. (Figure 2-3, 2-4)
- ii. Unit 101 and 102 balcony columns show visible signs of absorbing water at bottom stone base, as well as at upper unit balcony roof. (Figure 2-5 thru 2-8)
- iii. Primary roof run-off has been routed just above Unit #202 affected area by a downspout, but terminates on the balcony roof, resulting in added runoff at balcony roof edge. (Figure 2-3)
- iv. Catching runoff required from the water collection area (roof) to discharge point on the ground (splash block at ends of downspouts).
